To: Bill Wachler
SIPA Director

From: T.W. Petrie and Jeff Christian

Subject: Heating and Blower Door Tests of the Rooms for the SIPA/Reiker Project

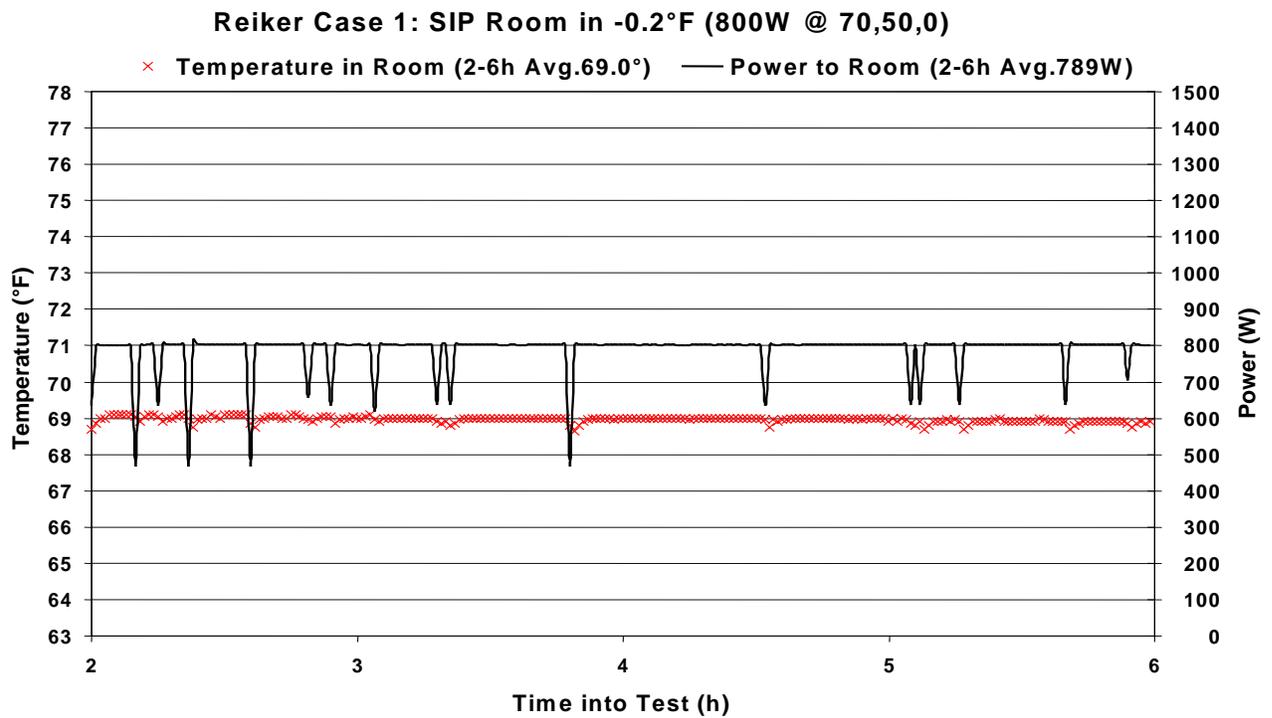
Figure 1. Example of Variation in Air Temperature and Heating Input Power for the Reiker Room Conditioner in the Room from Structural Insulated Panels.

Inside air temperatures, reported as the 4 hour average in Table 1, were measured at a height of 46 in. from the floor. The average at this height, the air temperatures outside and below the room and the raw heating power were obtained over the respective four hour periods by simply averaging the data that were reported at one minute intervals. Figures 1 and 2 show examples for the Reiker Room Conditioner in the SIP Room and the baseboard heater in the wood-framed room, respectively, of the time variations that are inherent to the inside temperature and raw power with the two methods of heating. The Reiker Room Conditioner clearly exhibits smaller fluctuations because its control method was more sophisticated than the one for the baseboard heater. The Reiker fan also generated considerably more air mixing within the test room space.

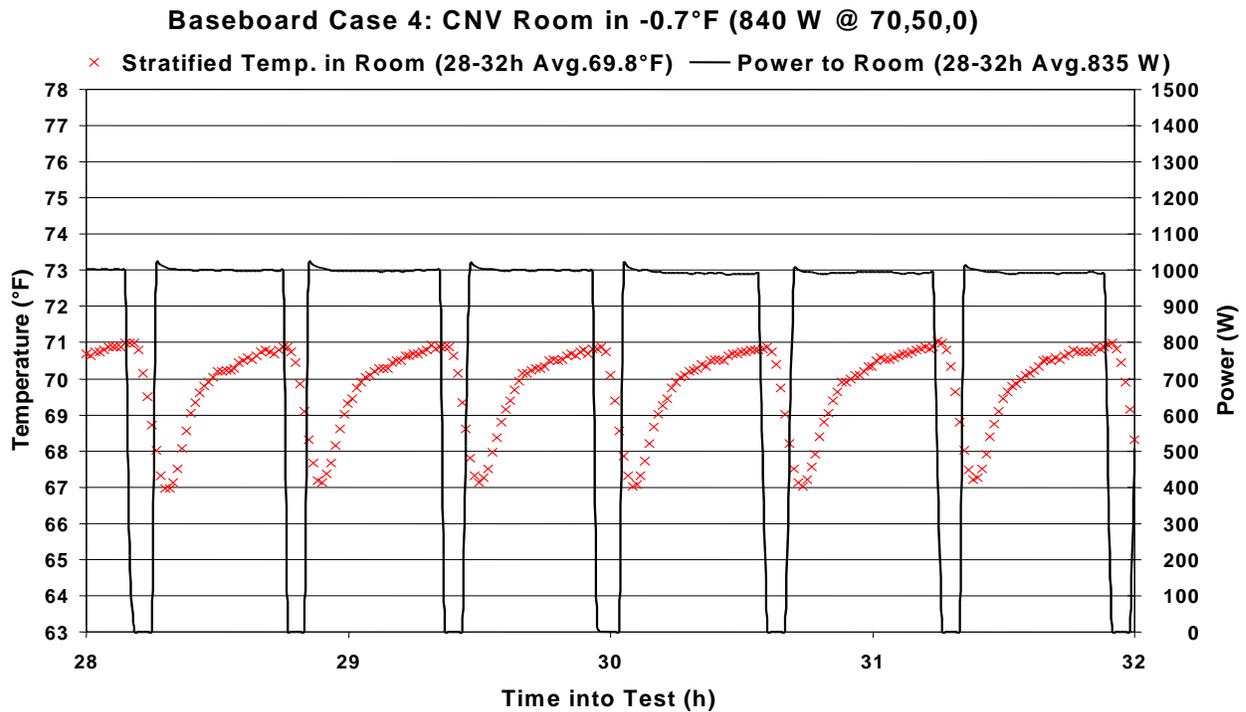
Figure 2. Example of Variation in Air Temperature and Heating Input Power for the Radiant Baseboard Heater in the Wood-Framed Room.

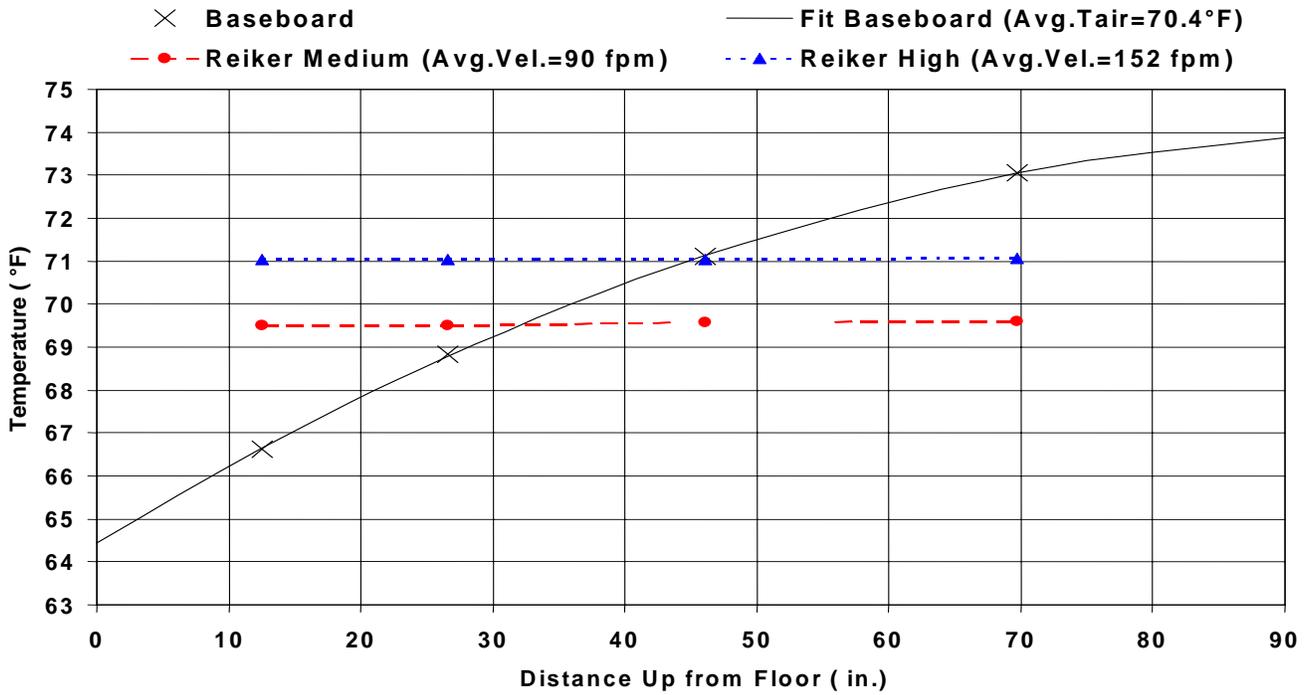
Figure 3. Stratification of Air Temperature from Floor to Ceiling of the Room from Structural Insulated Panels.

There is also a variation with height that is inherent to the inside temperature with the radiant-type baseboard heater. Figure 3 shows the significant stratification in air temperature from floor to ceiling with the baseboard heater and the complete absence of stratification with the Reiker Room Conditioner, in both the high speed fan and medium speed fan configurations for these tests. The average air temperature in the room with baseboard heating is 0.99 times the measured temperature at 46 in. above the floor. This small correction for inside temperature is included in the “Corrected Heater Power” data in the last column of Table 1.

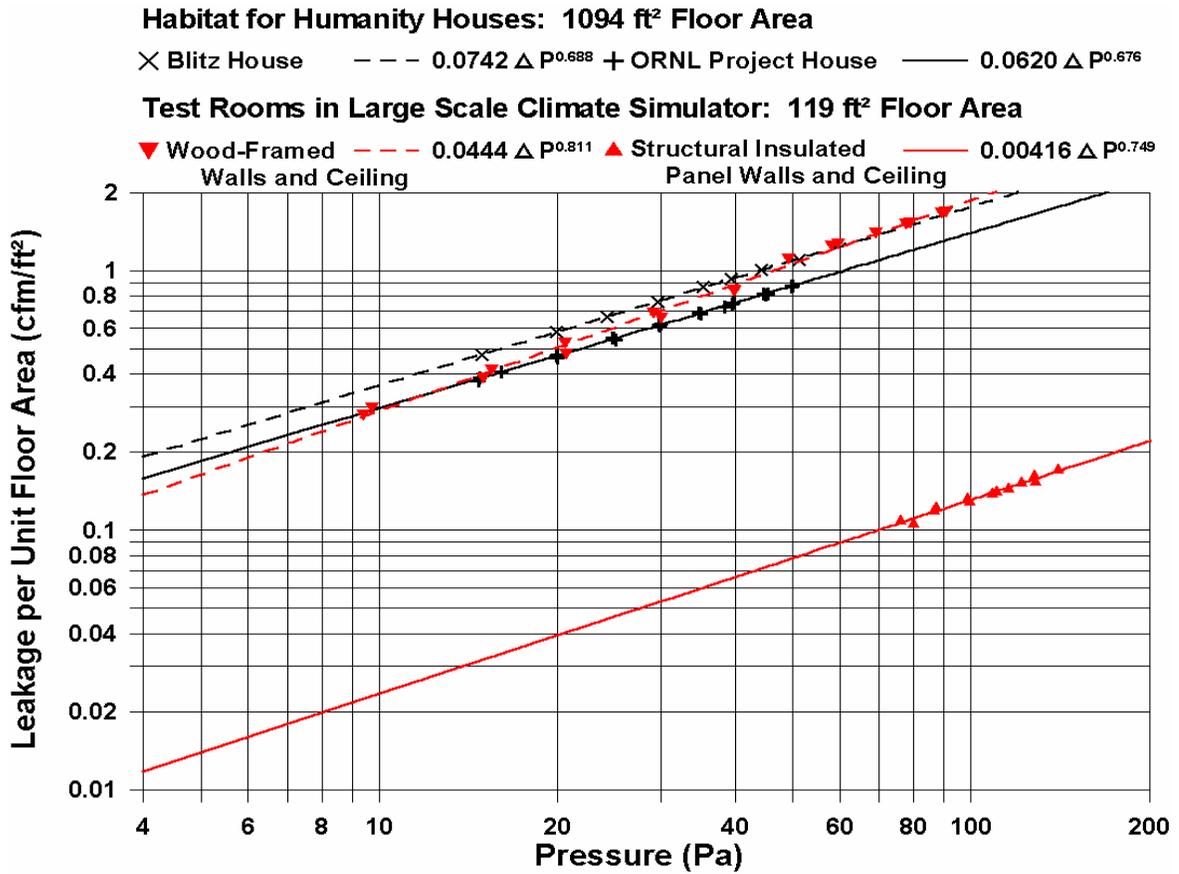
Figure 4. Blower Door Test Results for Whole Houses and the Test Rooms.

A common use of results from blower door tests is to estimate leakage area for wind-driven infiltration. One of the estimates of leakage area that is often used is the Lawrence Berkeley Laboratory effective air leakage area (LBL ELA) at 4 Pa. It extrapolates the results of the blower door tests to estimate leakage rate at 4 Pa. A smooth crack (discharge coefficient of 1) is then assumed and a calculation is made of the area to allow the leakage at 4 Pa. Figure 4 is a log-log plot of results of whole house blower door tests on two wood-framed whole houses with floor area of 1094 ft² and the current results for the 119 ft² rooms with no tape over room components (but the blower door enclosure well-taped). The results are extrapolated to 4 Pa by the equations shown in the legend.

The leakage per unit floor area for the SIP room compared to the wood-framed room retains the relationship shown in Table 2 that showed that the SIP room is almost 10 times less leaky. Leakage per unit floor area for the wood-framed room is very similar to leakage per unit floor area for the whole houses. The leakier of the two houses was a so-called “blitz” house for a Habitat for Humanity building project. A blitz house is built very quickly to get a project started with enthusiasm and could be expected to be leakier than one more carefully built. The other house was built for a side-by-side comparison to a house with a different exterior wall construction method. It could be expected that construction for it was done carefully so as not to prejudice the comparison.

Even though the leakage per unit floor area for the wood-framed room is about the same as for the two whole houses, the slope of the leakage with pressure is steeper. The values of the exponent for the wood-framed room and for the SIP room are larger than the 0.6 to 0.7 range that is usually seen with whole houses and is seen for the two Habitat for Humanity houses. This indicates that the cracks in these rooms present a longer path for air leakage than cracks in whole houses. A sharp sudden crack has an exponent of 0.5. A long path for a leak, like through a porous medium, has an exponent of 1.0.
